5th December 2011

Tree (Safety) Management Plan

Coogee Public School

Enviro Frontier Tree Management Pty Ltd

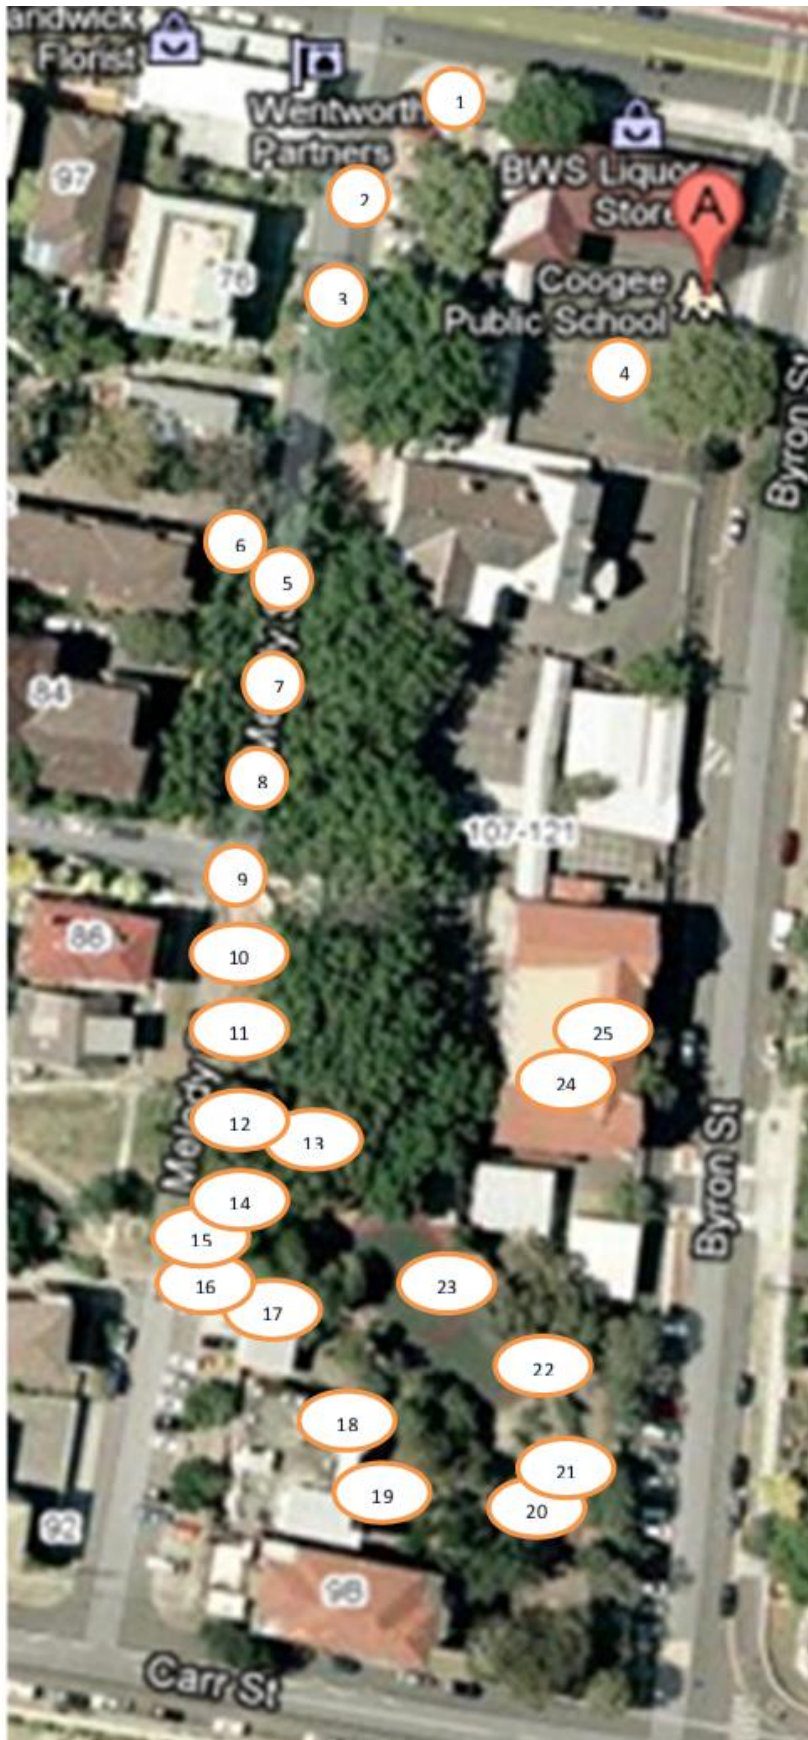
Appendix 1: SITE MAP OF TREE LOCATIONS

The Ficus in this stand are competing for light and soil nutrients. In the stand there are a total of 5 trees (numbered on site map 9 to 13), generally in this space provided for a tree of this vigour 3 is more than adequate, even 2 will suffice, considering the competing Council trees. The Ficus grows to 20 meters in height and can develop the same canopy spread in width. The risk with a Ficus in a high person/children area is the large scaffold branches. In the Ficus stand the lower branches are competing for light and have

extended horizontally exerting extensive weight on the main junctions. Our suggestion is to reduce the weight of these limbs along with removal two Ficus trees, one decline and the smaller Ficus. This will provide the other Ficus room to continue to develop. Ficus can live up to 200 years when properly managed and maintained.

NOTE- Ficus root system can cause significant damage and issues with structures and plumbing. It is noted that the school already has plumbing issues that can be attributed to Ficus root system. Also noted is the Ficus has caused lifting and uneven ground of the sponge matting that has been placed under the play equipment.

- Carry out pruning and dead wooding as specified in the summary of observations schedule
- Submit a Tree Application for the removal of tree assets as outlined in the report. A Tree order provides works can be carried out within 12 months of consent. Enviro Frontier Pty Ltd will provide this as part of the arboriculture service.
- Take down and remove trees as per the approval.
- Have all stumps on site where tree/palm removal has taken place ground to a minimum depth of 300mm. (Leaving stumps in the ground is not only unsightly; it also creates a trip hazard and promotes the breeding of destructive fungal pathogens. A schematic of underground services should be supplied to the contractor prior to the commencement of grinding works. The industry standard allows for stump grindings to remain on-site unless

- Consider a systematic removal program over the ten years to reduce the number of Ficus on the site.
- Where practical, leaf mulch or wood chip should be applied within the PRZ of all trees on site. The inclusion of leaf mulch will avoid damage to tree stem/roots, improve soil quality by the promotion of beneficial fungi sub-surface, and reduce compaction thereby improving soil quality and tree vigour. The application of mulch will also reduce maintenance costs via the reduction in mowing and water use. In short, it will reduce maintenance costs and reduce the incidence of disease and associated tree removals. (Mulch utilised should only be produced from native trees, be aged, free from seed/pests and be spread at a depth of 75mm. Mulch should be kept away from the stem of young plants.)
